# External Environmental Monitoring Report

Semestral Report: January - June 2025  
December 2025

## Pakistan: Balakot Hydropower Development Project

Prepared by Dr. Abdul Qayyum Aslam, External Environmental Monitor for the Government of Pakistan and the Asian Development Bank (ADB).

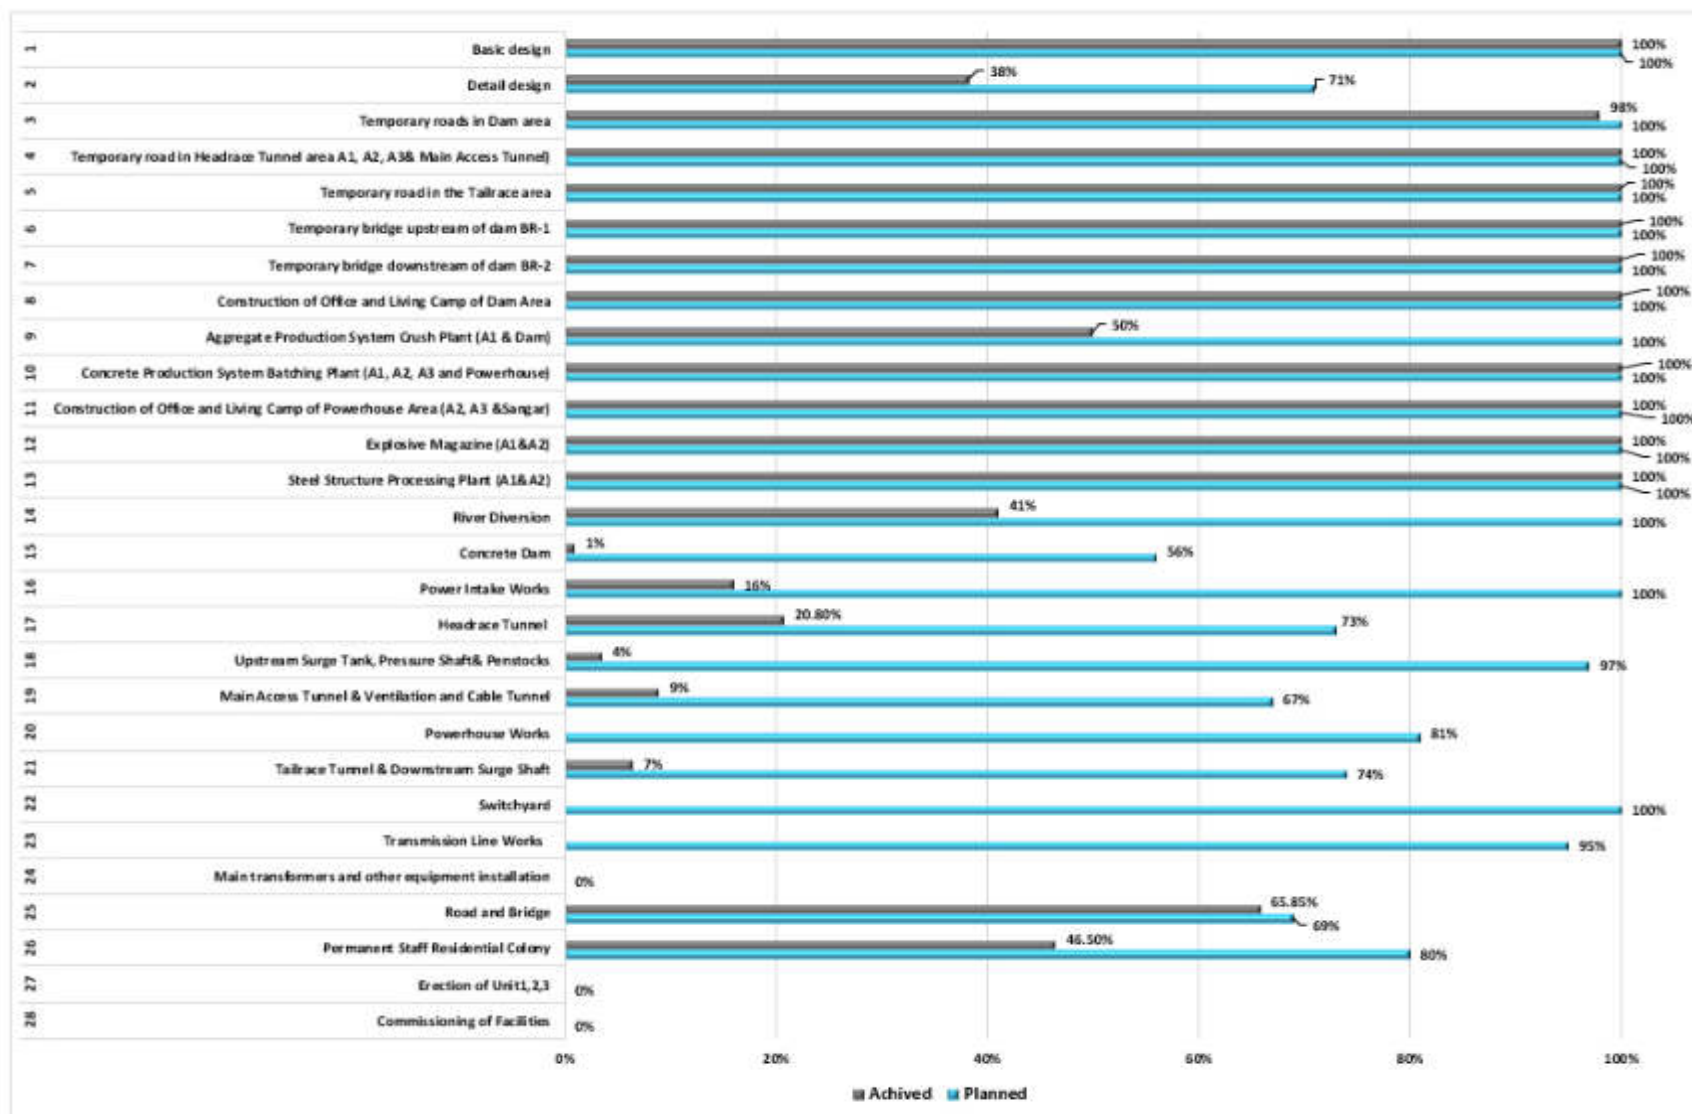
Figure 2-3: Physical Work Progress- BHPP

47. Project civil works started in September 2022 and about 13.83% of work got completed in December, 2024 while about 19.29% as of June, 2025.
48. Major activities that were carried out during reporting semester include detailed design (38.3%), Aggregate Production System Crush Plant A1 & Dam (50%), River Diversion (41.6%), Concrete Dam (1.0%), Power Intake Works (16.0%), Headrace Tunnel (20.8%), Upstream Surge Tank, Pressure Shaft & Penstocks (3.53%), Main Access Tunnel & Ventilation and Cable Tunnel (8.96%), Tailrace Tunnel & Downstream Surge Shaft (6.5%), Road and Bridge (65.85%) Permanent Staff Residential Colony (46.5%).
49. Physical work progress during monitoring period is provided as **Figure 2-3**.

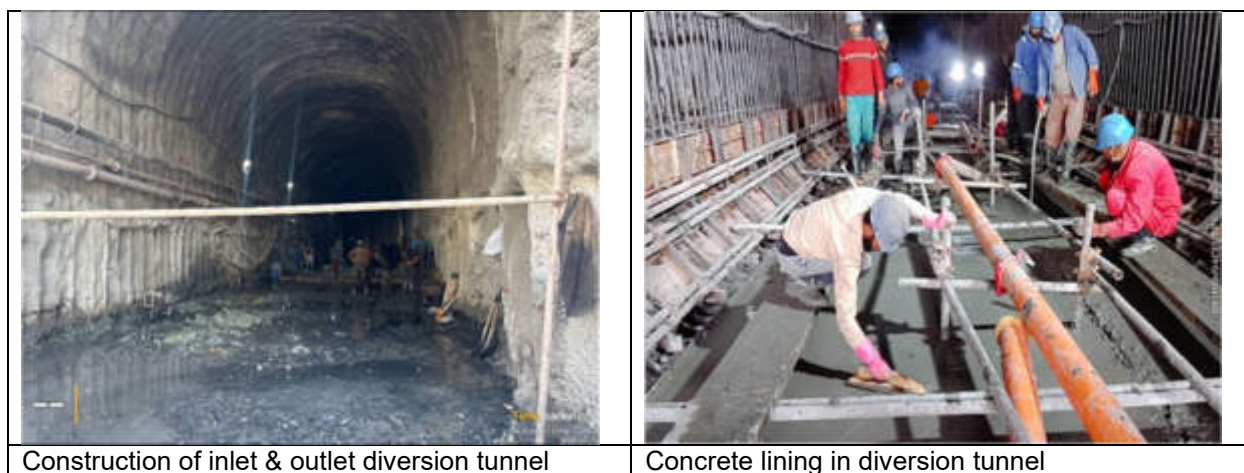
**Figure 3-1: Construction of Diversion Tunnel**

54. A diversion tunnel is being constructed on the left bank of the river which will also act as low-level spill way. The area is hilly terrain of steep slope surrounded by pine scrub forest mountains. Photographs of construction of the diversion tunnel are provided below as **Figure 3-1**.

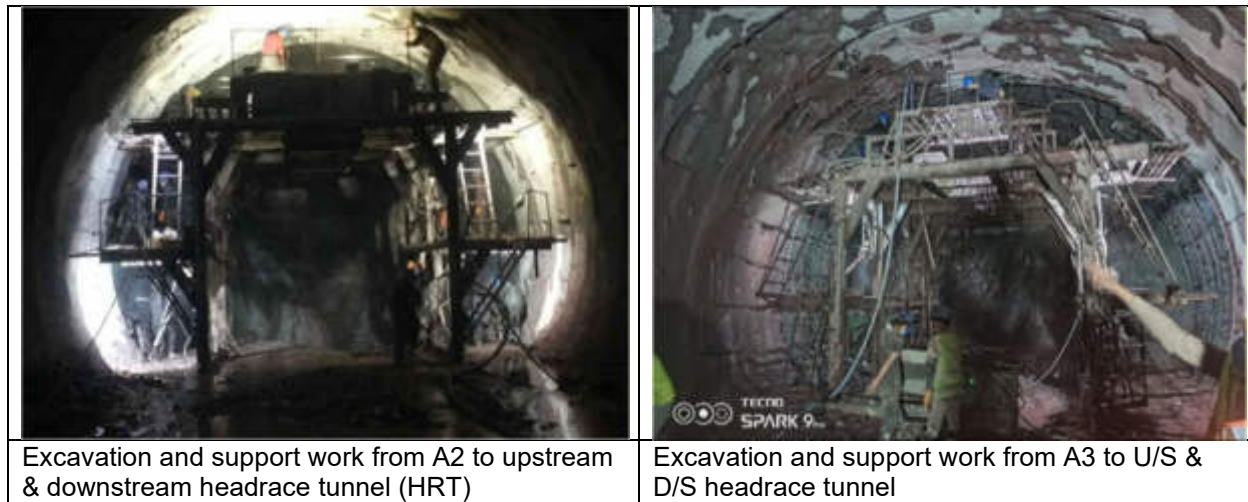
**Figure 3-5: Construction of Headrace Tunnel**

55. A head race tunnel of 8 m diameter and about 9.1 km length will be constructed on the left bank of river. The tunnel will comprise of three ADITs for access and passage to the tunnel. The headrace tunnel traverses Kiwai, Zamanabad, Kholian, Barkot, Kappi Gali and Sandhu localities. Construction work on the headrace tunnel remained in progress during reporting semester and about 20.8% work against 73% planned work has been completed. Construction activities commenced so far and typical setting of tunnel is shown below as **Figure 3-5**.

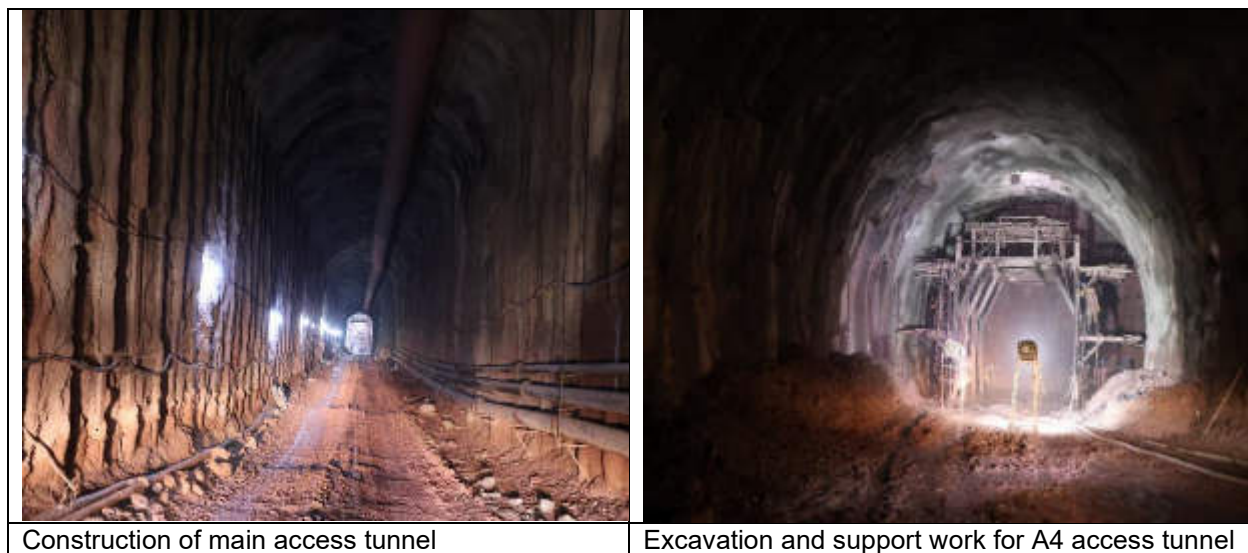
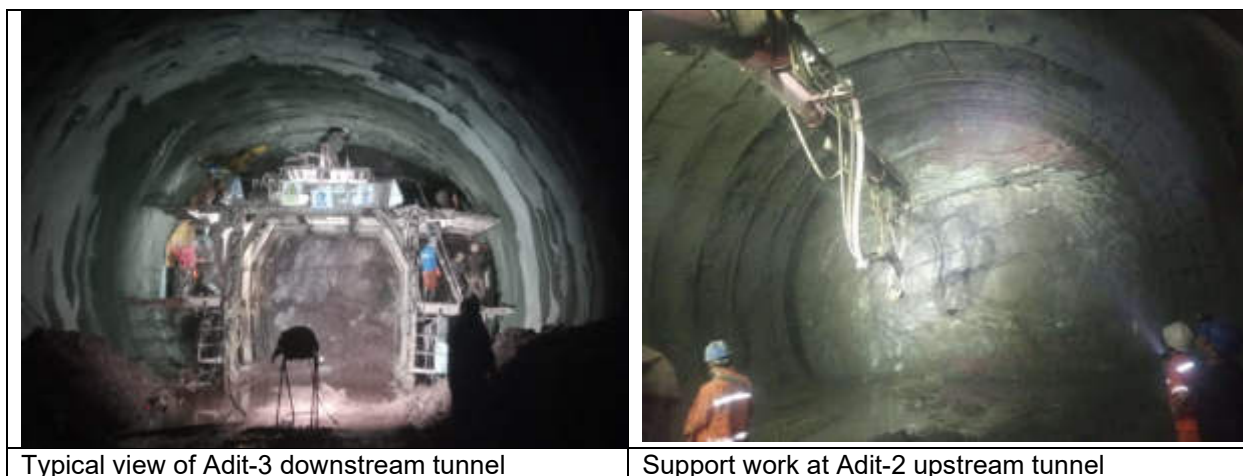
**Figure 3-6: Overview of Construction Activities at Main access and Adit Tunnels**

56. Construction work on Adit tunnels also remained progress during the reporting period. Construction works of Adit tunnels are shown in the below **Figure 3-6**.

57. During reporting semester, work on main access tunnel remained in progress. About 9% work against 67% planned work has been completed.

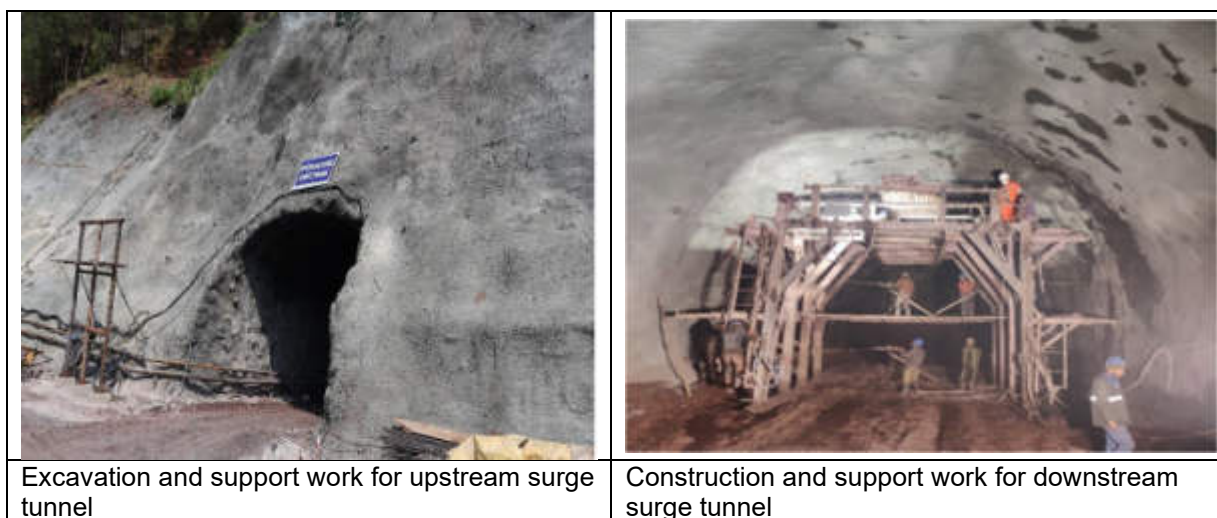
**Figure 3-7: Construction work of Surge Shaft, Pressure Tunnel and Power House**

58. The Surge shaft, pressure tunnel and powerhouse are in Sendori near Kappi Gali. Surge shaft and pressure tunnel will be located at an elevation of 1220 m while powerhouse turbine axis is located at elevation of 1050 m amsl. An underground cavern-type powerhouse will be constructed. Construction work of surge shaft and pressure tunnel remained in progress during the reporting semester and about 4% work has been completed against 97% planned progress. No construction work started at powerhouse site. Glimpses of construction activities at surge shaft and pressure tunnel are shown below as **Figure 3-7**.

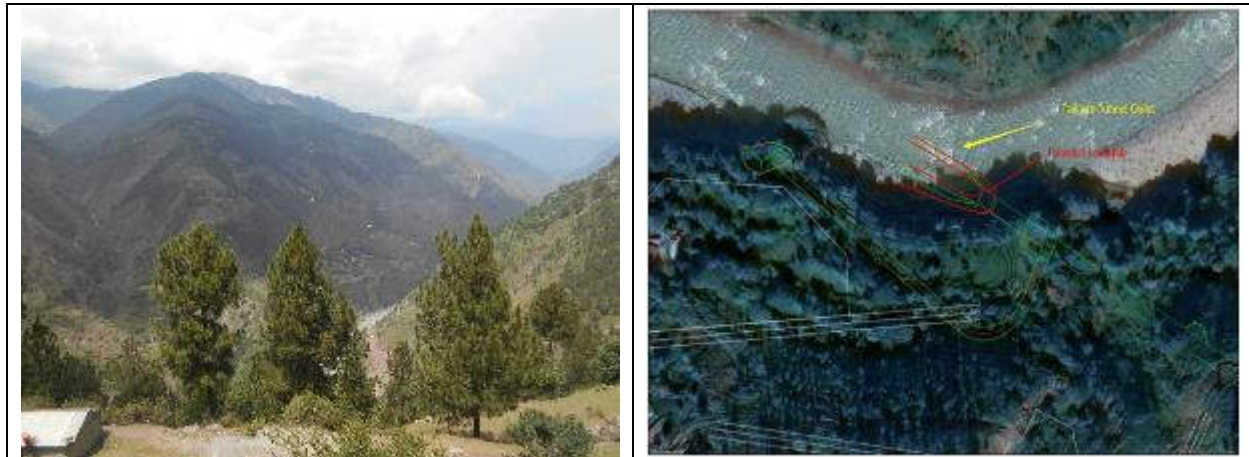
**Figure 3-8 Typical setting of Tail Race Tunnel**

59. The tailrace tunnel will be constructed up to 1.565 km length and will be comprised of circular tunnel with archway section transition at outlet portion. It is also located in Kapi Gali and ultimately outfall in the Kunhar river. During reporting month no work on tailrace started. Typical setting of tail race tunnel area is shown as **Figure 3-8**.

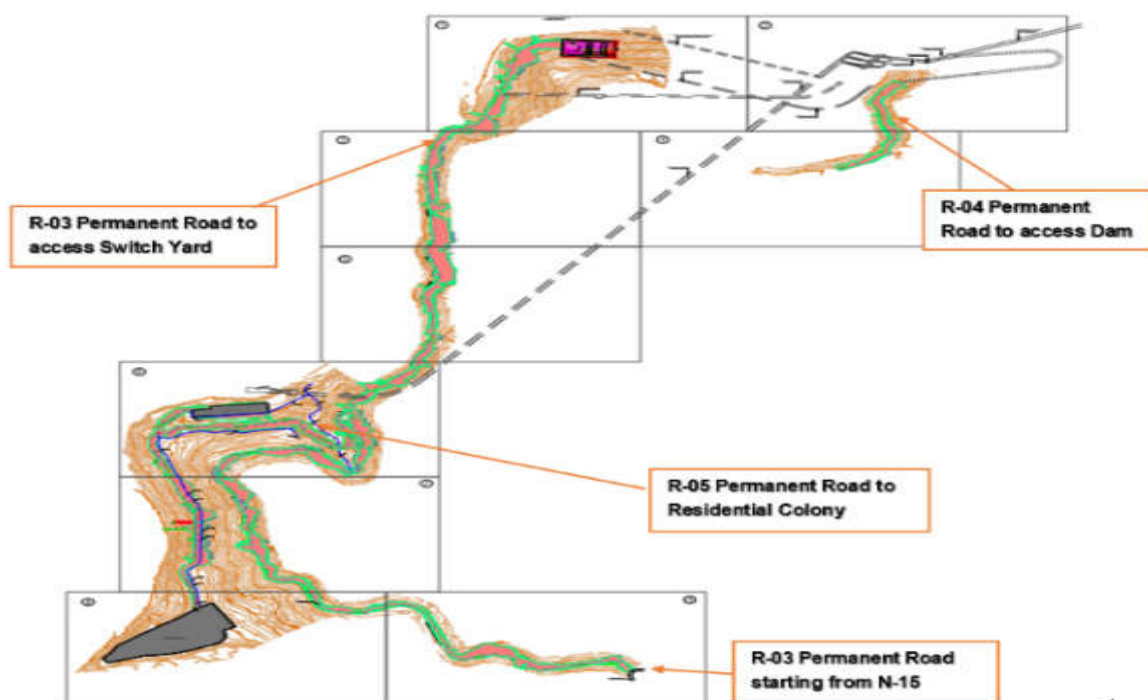
**Figure 3-9 Alignment of Permanent Access Roads**

60. There are three permanent roads included in project design. These are a permanent road to Dam (R-4) and to the Powerhouse (R-3) and to project residential colony sites (R-5). The R-5 originates from R-3 near tailrace colony site and will be used to access permanent residential colony. Earth works including cutting, filling, protection works, compaction and asphaltting are the major activities being executed at the permanent roads' sites. There is one proposed bridge at the reservoir area that will connect the main N-15 road with the adjacent roads on the left and right sides. The main activities are piling, span girders, railing works, parapet walls, and surfacing. Permanent access roads alignment is provided below.

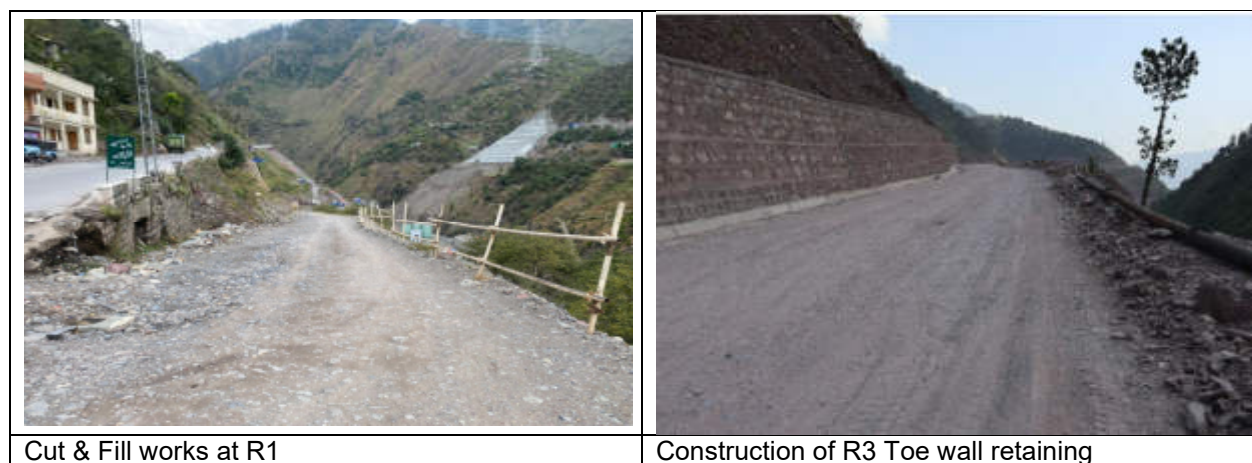
**Figure 3-10 Construction Pictures of Access Roads**

WBM spreading and compaction work at R3	Construction of toe retaining wall at R-4

Work in progress at R-5	Work in progress at R-6

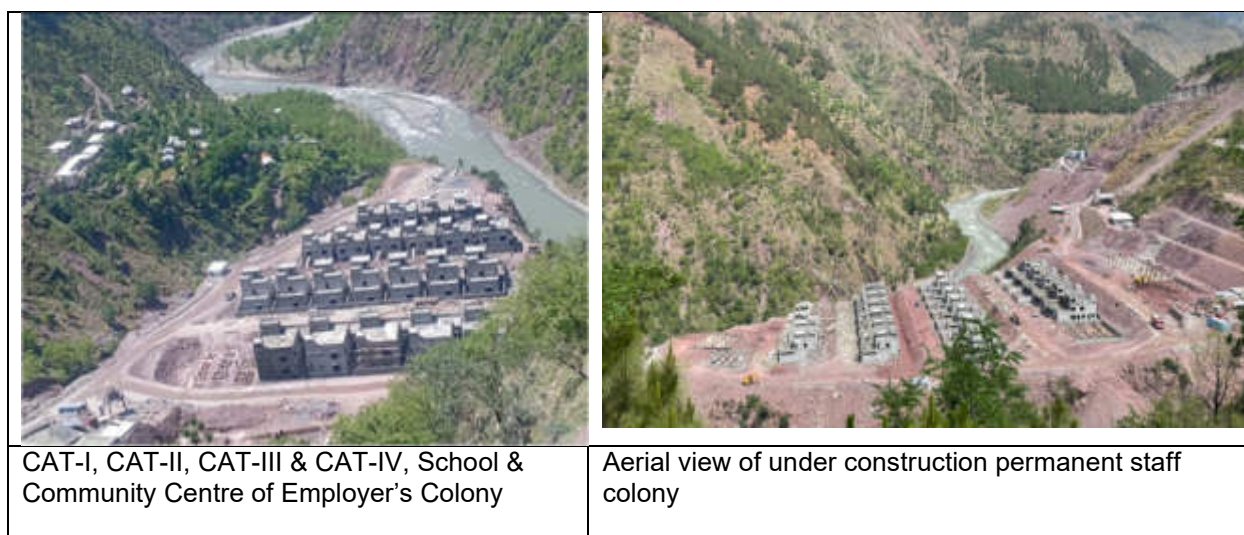
**Figure 3-11 Construction works of Staff Colony at Ganhool Village**

63. Construction of staff colony is part of the project design for which land has been acquired at Ganhool village. Design of staff colony is completed, and construction work is in progress. The colony will comprise of residential units and offices for the project operational staff. It will be a permanent residential colony for the staff during the construction and operation phase of the project. It will house residential units of categories I-IV, community center, school, shopping market, mosque, hospital and other civic facilities, sewerage treatment plant and reasonable land is allocated for green spaces and park in the layout plan of the colony. Protection works, concreting, and brick masonry are some of the major construction activities to be undertaken at the site. As of June, 2025, works on category II, III and Category IV buildings of staff colony remained in progress. About 46.5% physical work out of 80% planned progress is completed. Master plan of staff residential colony is provided as **Annexure F**.

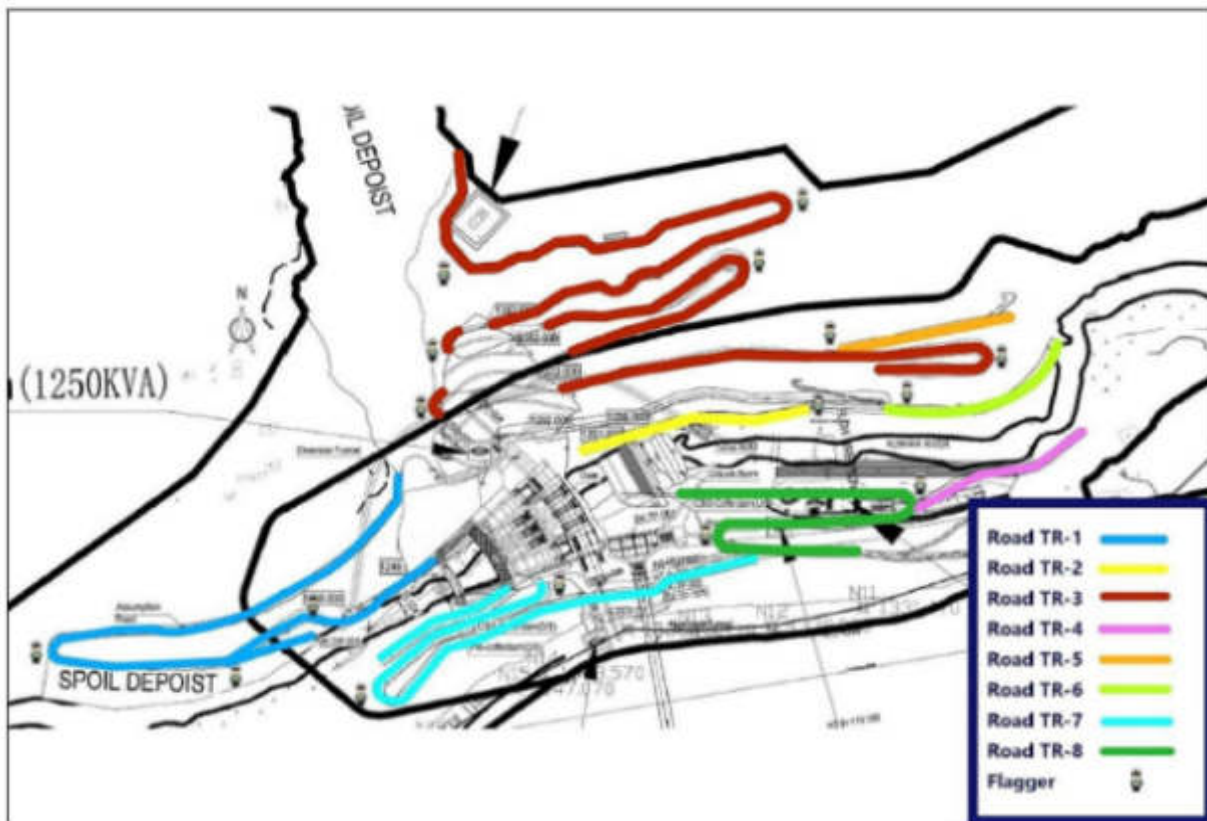
**Figure 4-9: Layout of Temporary Access Roads to the Dam Site**

73. Initially eight TRs are envisaged to be constructed to access the dam site area. EPC contractor has completed major works on TRs leading to dame site, Adit-01, Adit-02, Adit-03 and Powerhouse site however allied works such as road widening, slope stabilization, provision of drainage system and construction of retaining walls remain in progress at the end of reporting period. The layout of access roads is shown in below figure.

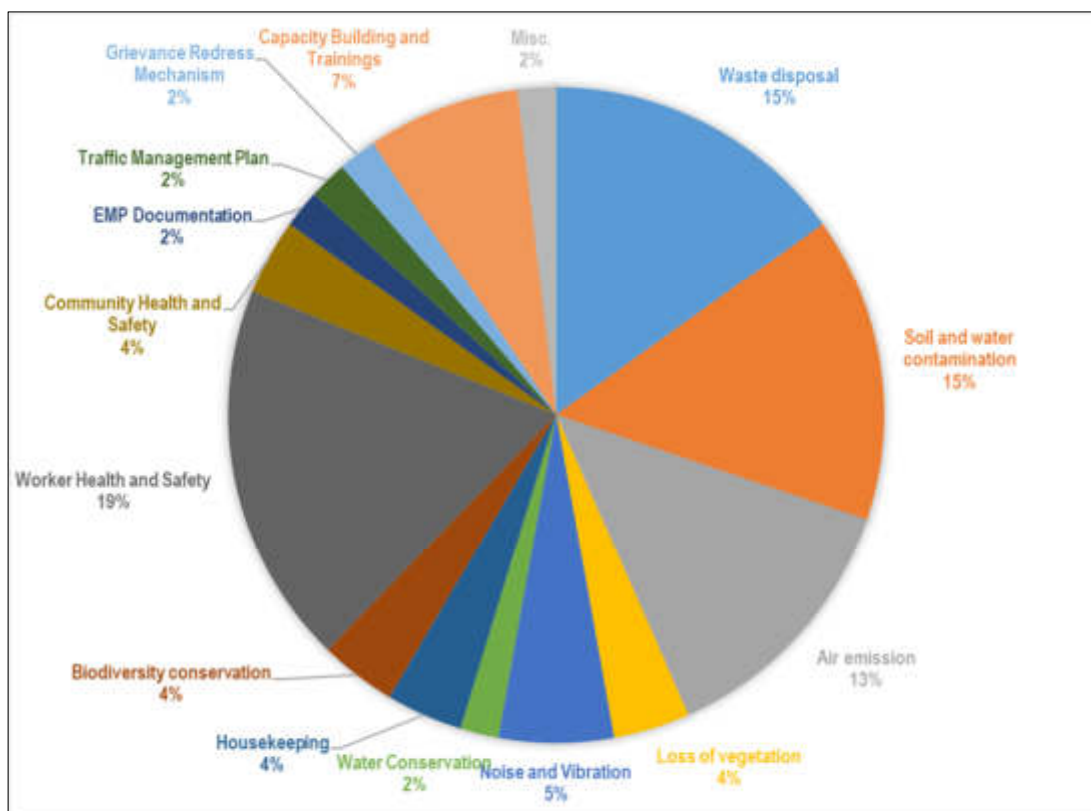
**Figure 7-2: Category wise breakdown of non-compliances**

19. A total of 53 environmental non-compliances of EMP/SSEMMP/BAP were recorded during monitoring period. About 31 non-compliances were minor, 17 moderate and 05 major non-compliances. Major non-compliances are; waste stabilization ponds are not constructed for tunnels, the constructed pond at Adit-2 is inadequate and not functioning properly, improper dumping of muck cuttings near streams, poor living conditions in the camps and violations of work at height procedures. CAP to close out observed non-compliances is provided in this EEM report.

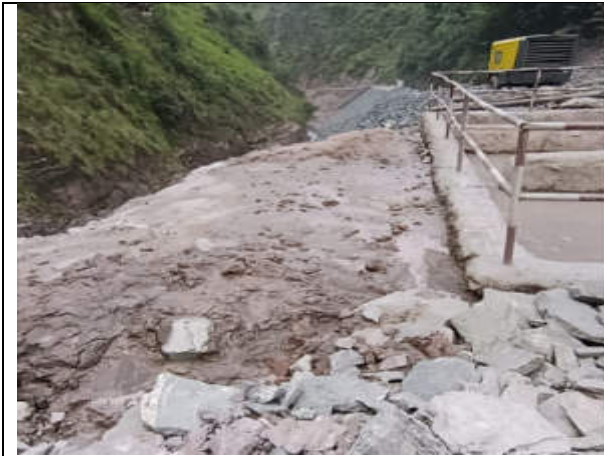
Poor function of sedimentation pond at Adit-2

189. Photographs of environmental non compliances observed during EEM visit and required corrective actions are provided as **Figure 7-3**.

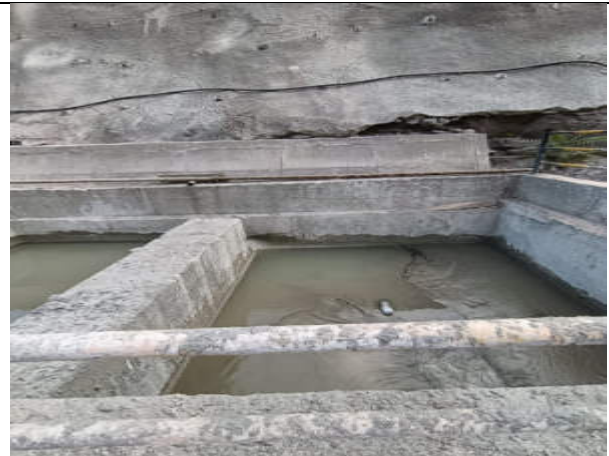
Sedimentation tank of batching plant at dam site is filled with sludge

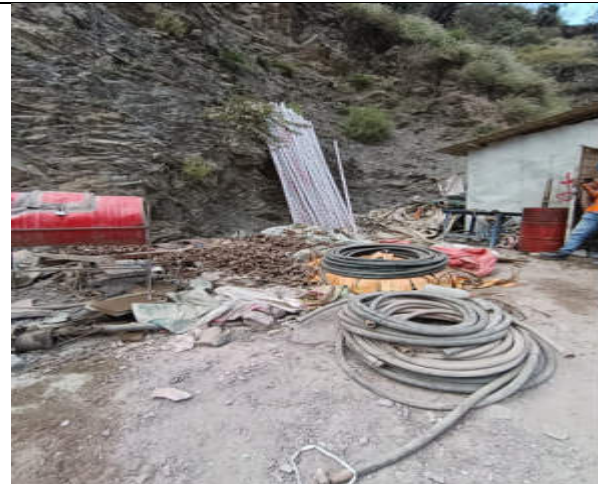
Poor housekeeping at diversion inlet tunnel

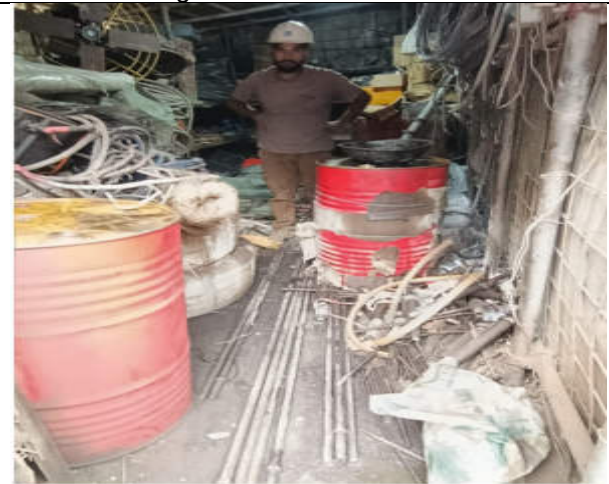
Fuel drum is placed in store- potential risk of fire

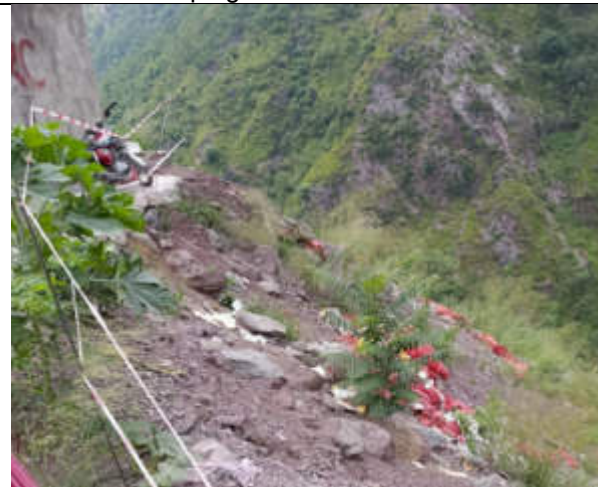
Improper disposal of waste at entrance of colony area

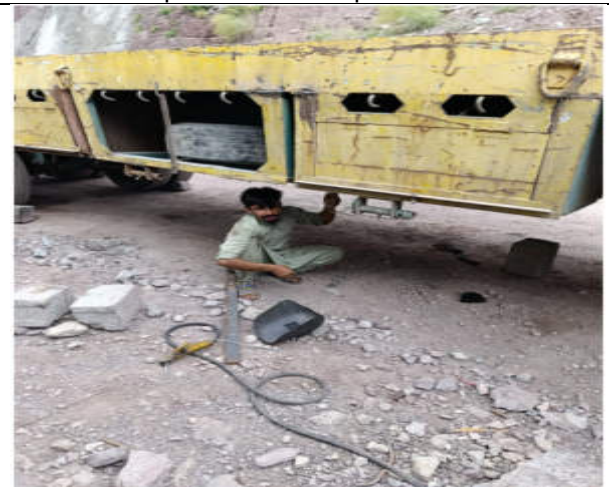
Worker observed working without PPEs

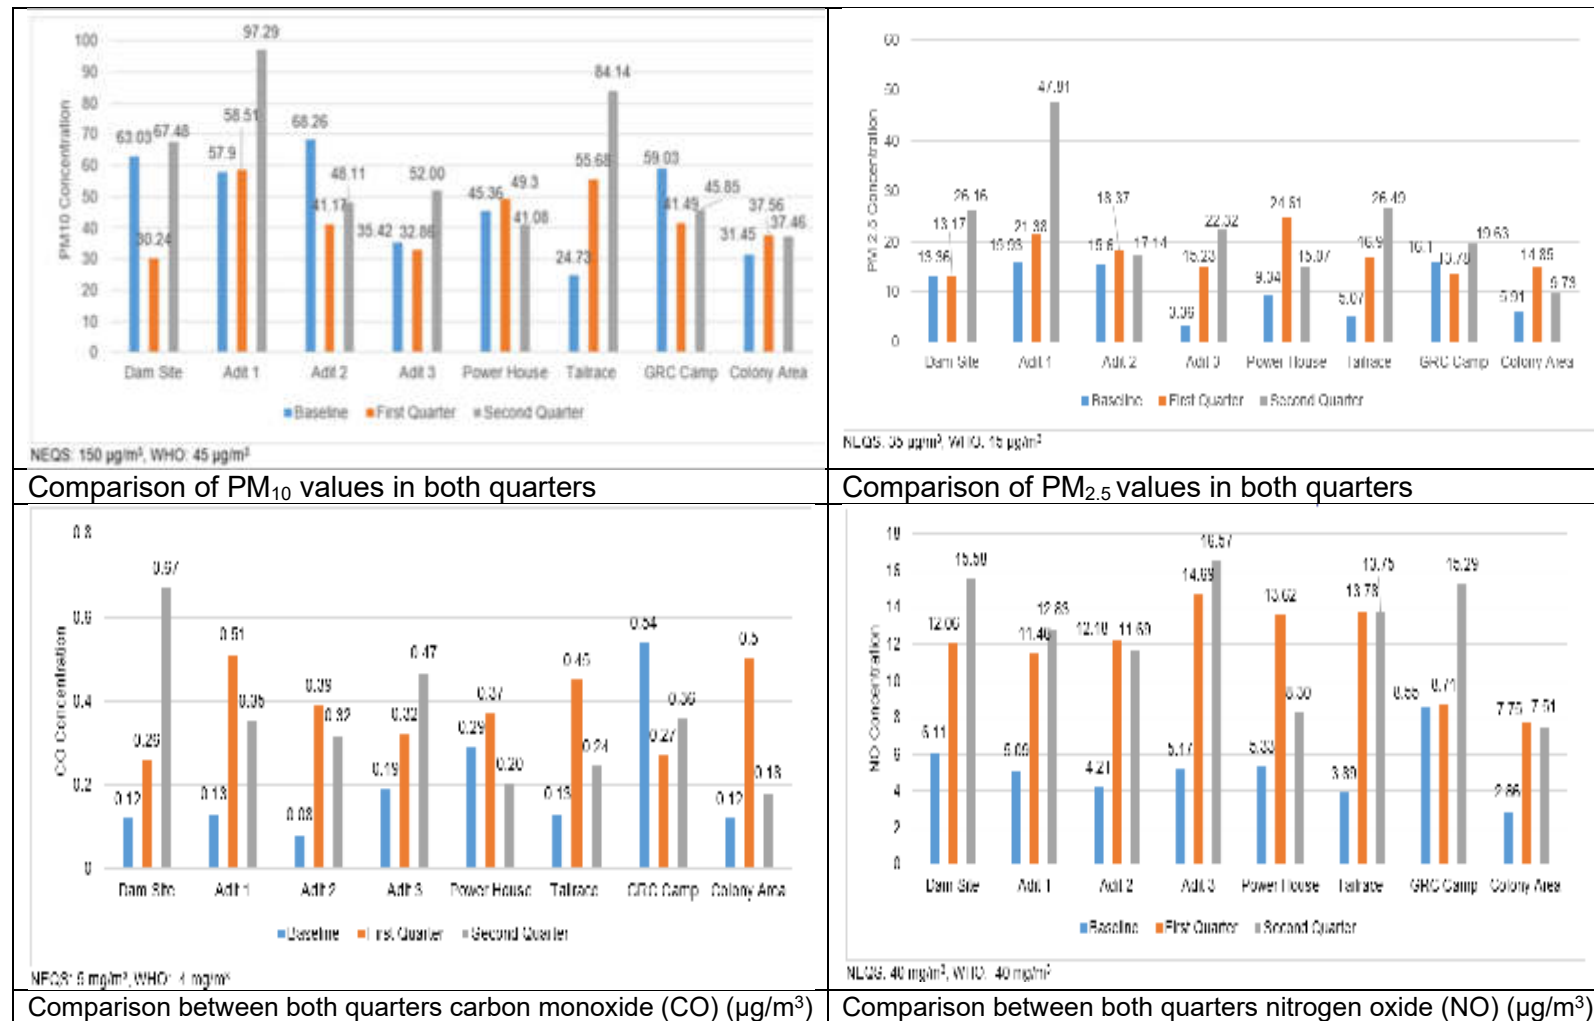
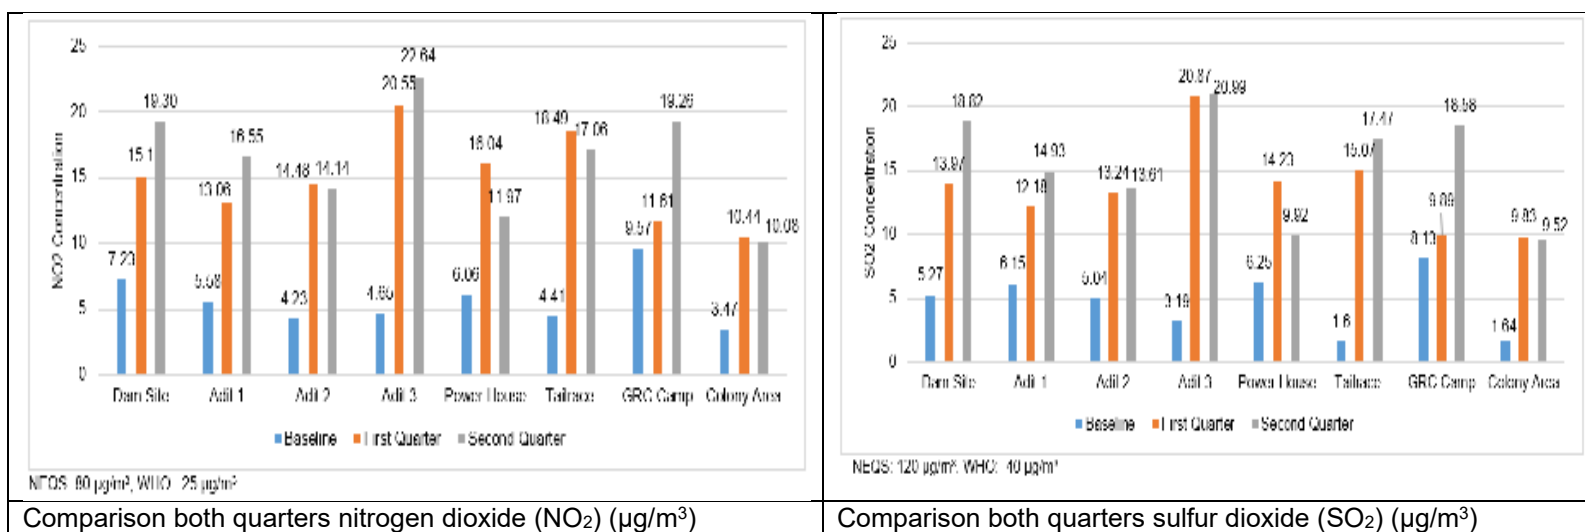
Figure 8-2: Ambient Air Quality Analysis BHPP

203. The obtained results for SO<sub>2</sub> concentration at all monitored location fall well within WHO and NEQS values in both 1<sup>st</sup> and 2<sup>nd</sup> quarter.
